MEMORANDUM

TO: ARCHITECTURAL REVIEW BOARD
FROM: Kate Schwartz, Historic Resources Planner
DATE: June 13, 2016
SUBJECT: Certificate of Appropriateness for exterior alterations at 201-203 William Street

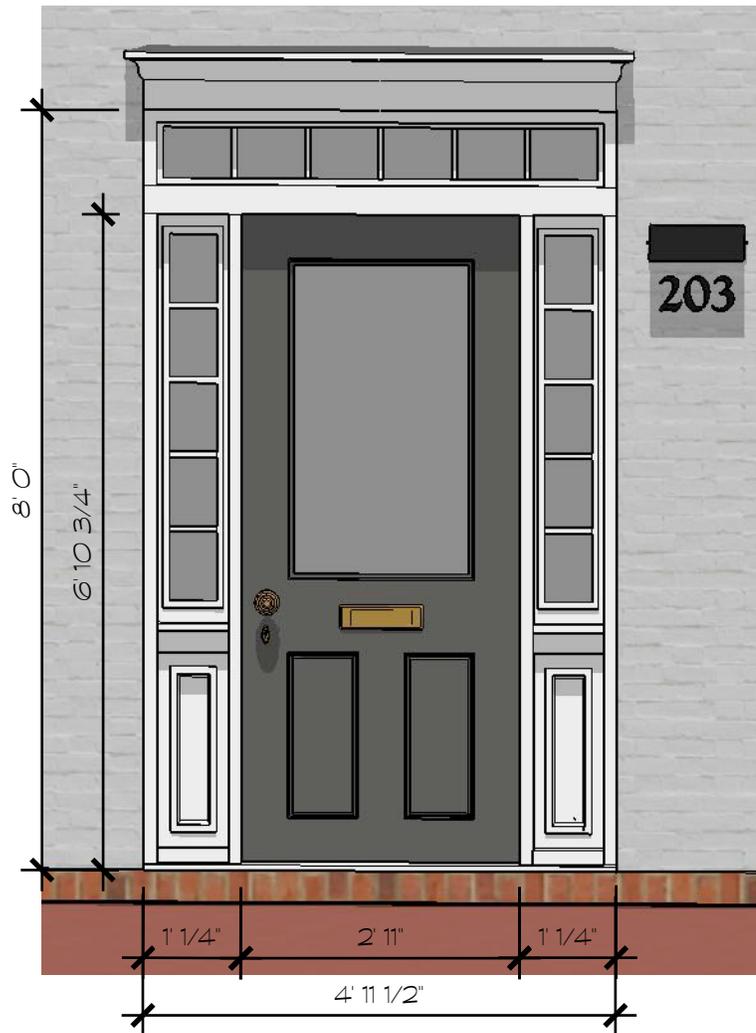
NEW DOOR

SCALE: 1'-0" = 1/2"

The applicant has provided additional documentation to show that the proposed entry door will fit into the existing window opening on the 203 William Street façade. The applicant has withdrawn the request to replace the roof with synthetic slate.

- The display window centered in the 203 William Street elevation will be replaced with a half-glazed, two-panel wood entry door with sidelights and transom to fit the existing opening in the brick. The existing display window is not a contributing feature of the building, and a door was historically placed in approximately this location. Staff finds that this alteration reflects the original configuration of the property and is compatible with the character, materials, and design of the structure.
