## MEMORANDUM

**TO:** ARCHITECTURAL REVIEW BOARD  
**FROM:** Kate Schwartz, Historic Resources Planner  
**DATE:** May 9, 2016  
**SUBJECT:** Certificate of Appropriateness for exterior alterations at 201-203 William Street

Dan Hebron requests a Certificate of Appropriateness for exterior alterations including:

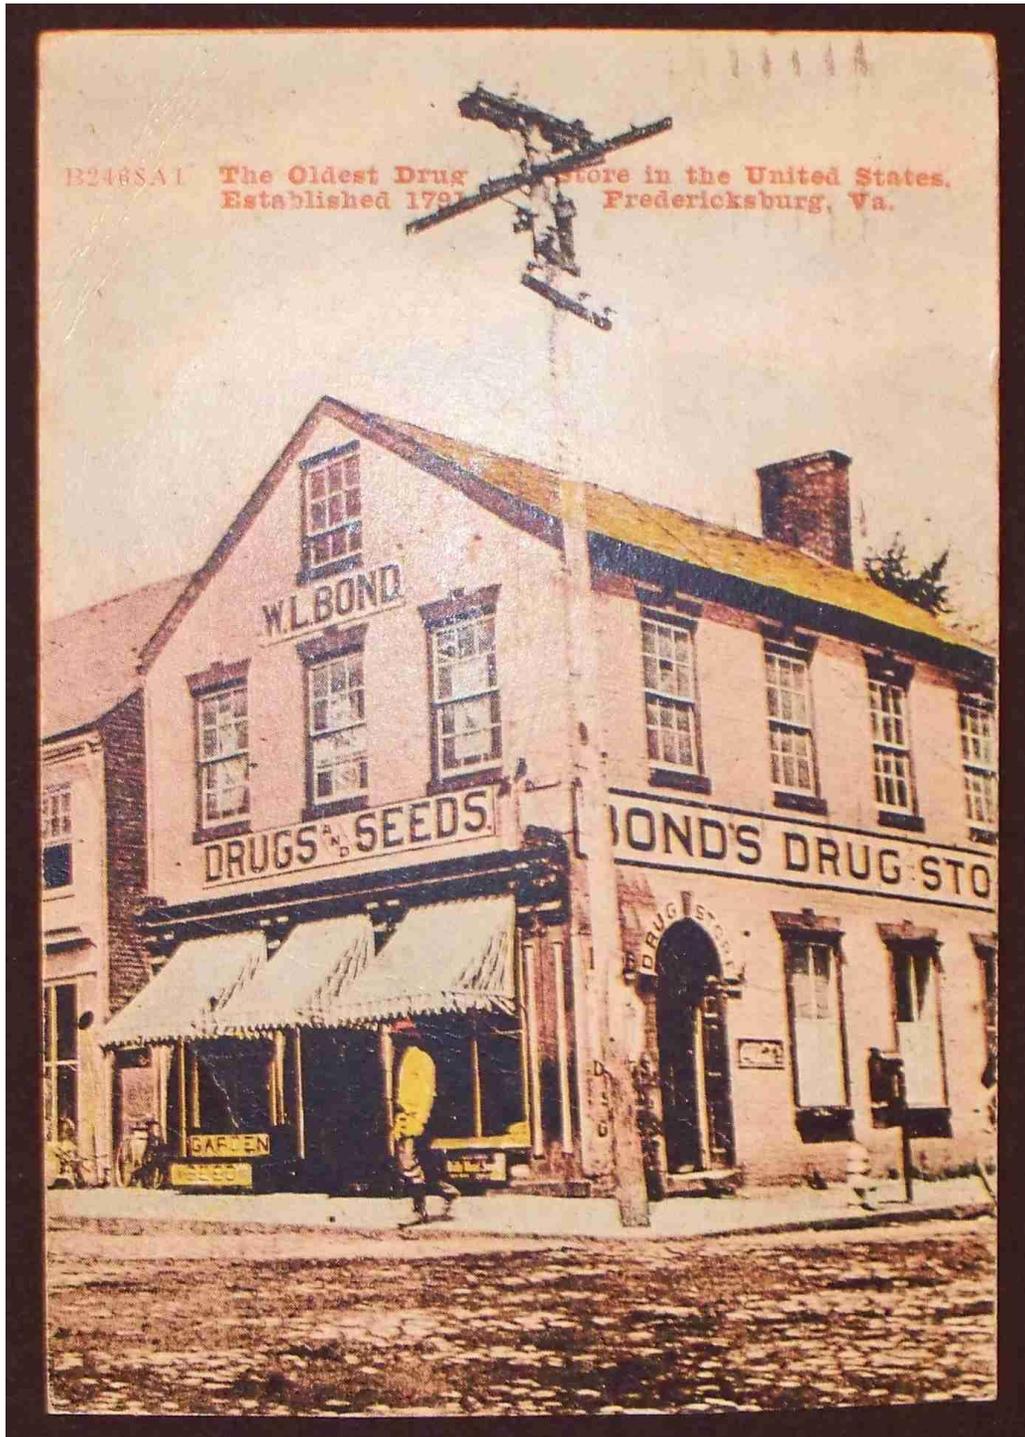
**Postcard, c.1907**

Featuring Bond's Drug Store

Note the gap between the two structures at 201 and 203 William Street.

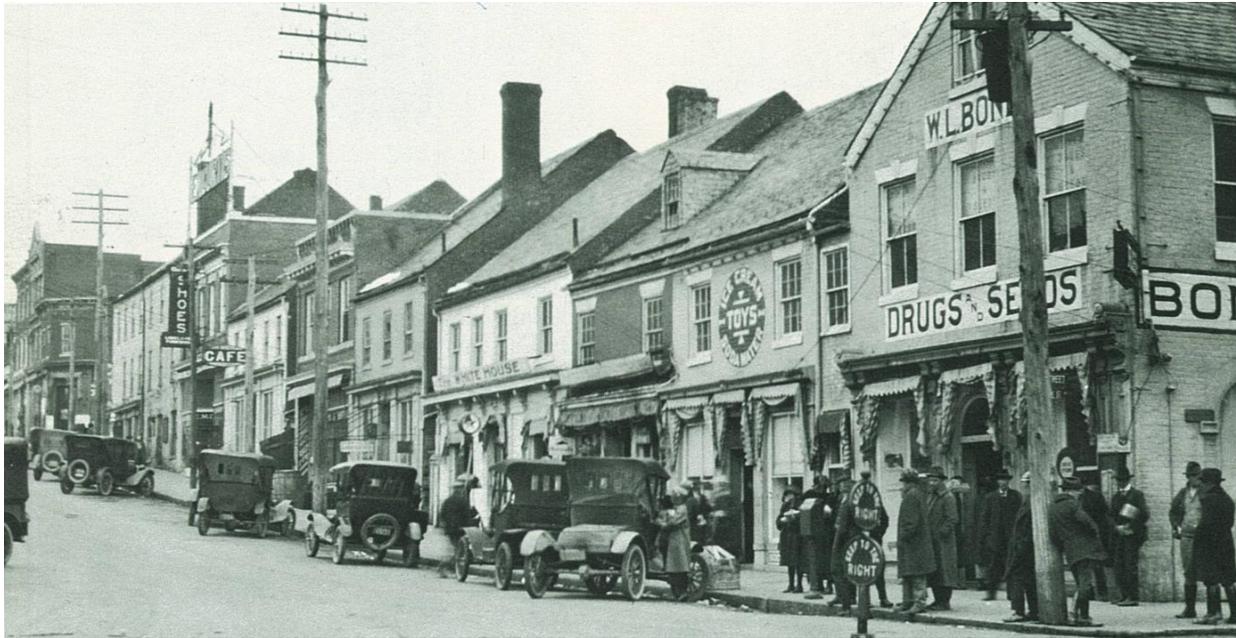
**Bond's Drug Store, c.1924**

Note that the gap between 201 and 203 William has been filled and windows appear in this location. Also note the entry door and window configuration on the 203 William building.

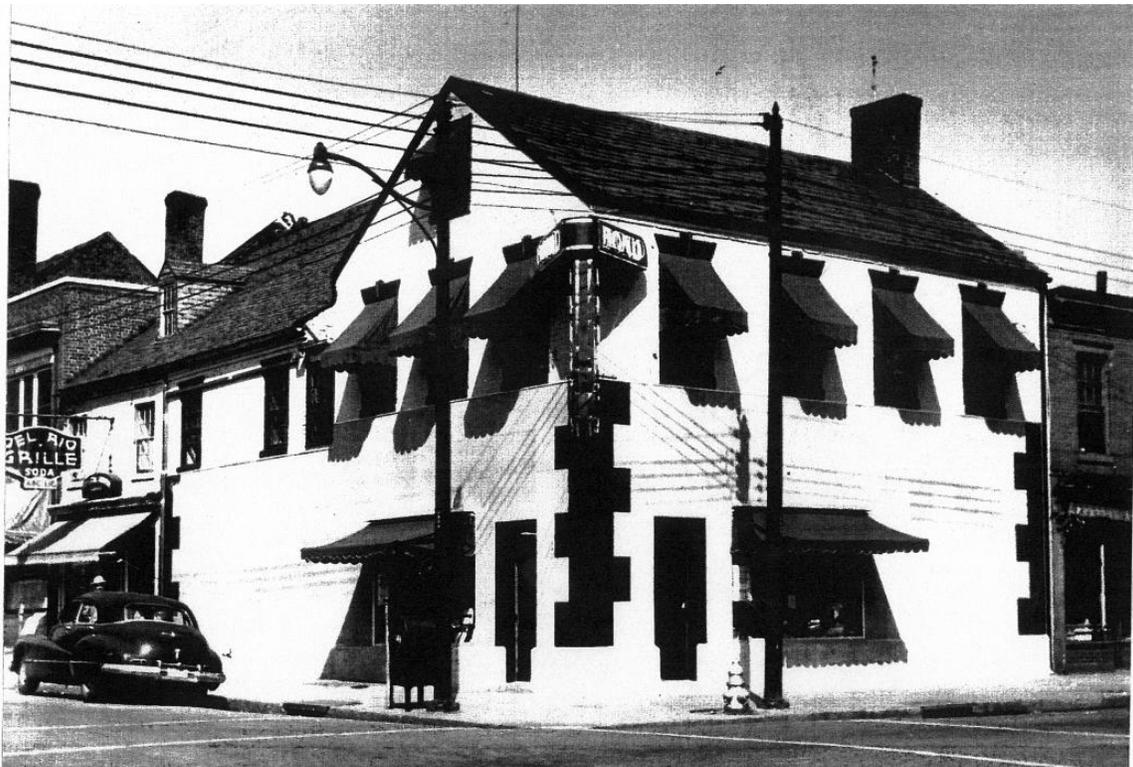
**Bond Rexall Drugs, c.1950**

Note the corner entry, reconfiguration of ground floor windows, and removal of the 203 William entry.

- The aluminum corner entry paired doors will be replaced with a single glazed wood door, sidelights, and transom. It is unknown if the existing doors are original to the c.1946-1950 corner entry configuration. The proposed design maintains the existing entry and is compatible with the character, materials, and design of the structure. The alteration is compatible with the character of the Historic District.

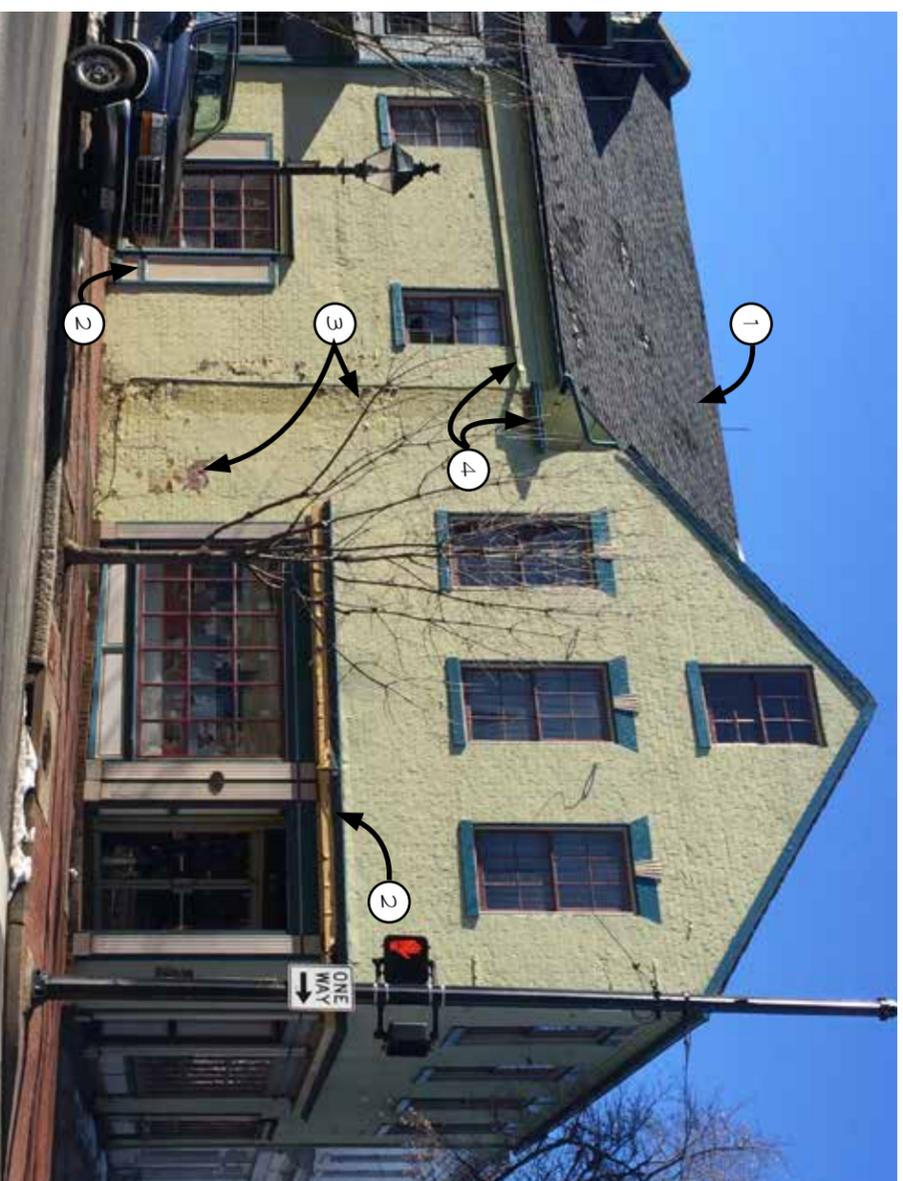
**WILLIAM STREET FACADE**

1. Consider repair and patching of slate roof prior to complete replacement with synthetic slate roof shingle. If roof is deemed beyond repair, contact VMS architect for synthetic slate sources that have been accepted in other historic districts in Virginia. Ensure approval of substitute by your municipality prior to purchase of material.

2. Remove wood shutters. Repair or replace wood trim on first floor storefronts and windows. Prime and paint all trim.  
\*\*\*Scrape loose paint from existing masonry. Patch and repaint to match existing. Ensure mortar is suitable for early 19th c. brick masonry. Prime and paint.

4. Replace and re-route gutters and downspouts. Paint downspouts to match wall color, and paint gutters to match trim color.
5. Replace wood window with new wood entry door, sidelights and transom to fit opening. Prime and paint. See 203 Williams St. Facade on Sheet A.4.

7. Note not used.
8. Note not used.
9. Install new fabric awnings with loose 6" deep valances and open corners to allow valances to move freely. Tightly fit frame between pilasters and under cornice overhang on 201 Williams St. building.

- The display window centered in the 203 William Street elevation will be replaced with a half-glazed, two-panel wood entry door with sidelights and transom to fit the existing opening in the brick. The existing display window is not a contributing feature of the building, and a door was historically placed in approximately this location. Staff finds that this alteration reflects

- New fabric awnings with loose six-inch deep valances and open corners will be installed between the pilasters and beneath the cornice, over the display windows on the 201 William Street building. Awnings were previously installed over these display windows, as shown in the c.1950 photograph. The placement, design, material, and color of the proposed awnings are compatible with the historic character of the structure and the District.

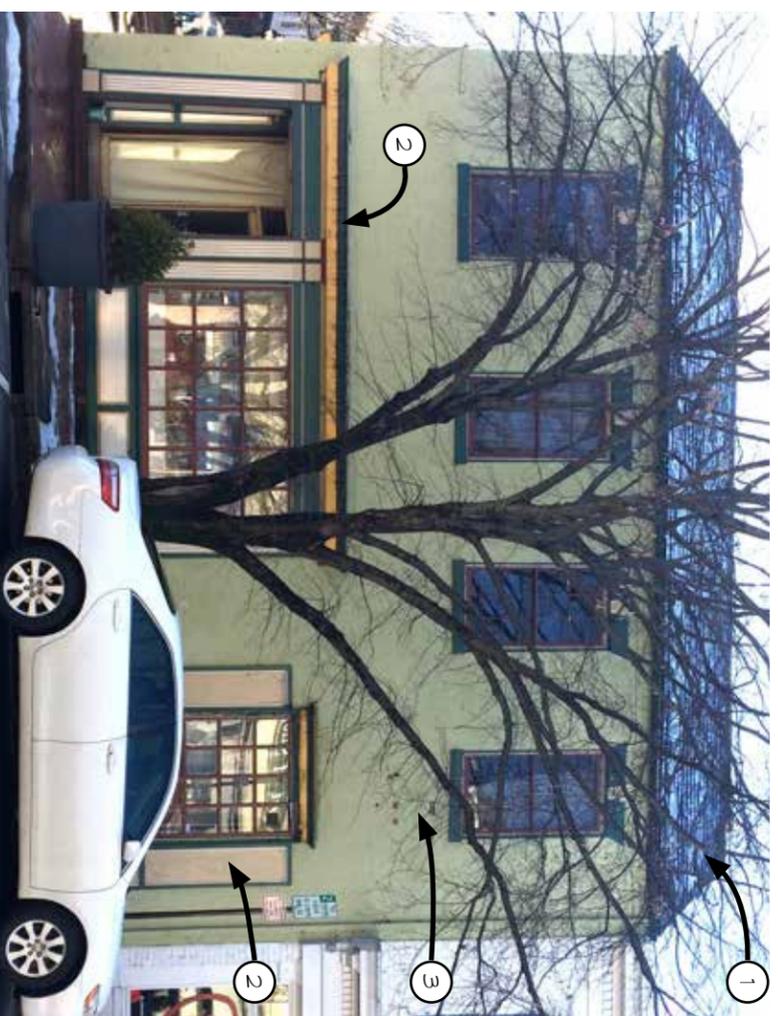
**CAROLINE STREET FACADE**

6. Install new wood recessed entry (3'-0" door) and sidelights using existing entry footprint. Prime and paint. See New Recessed Entry Detail on Sheet A.4.

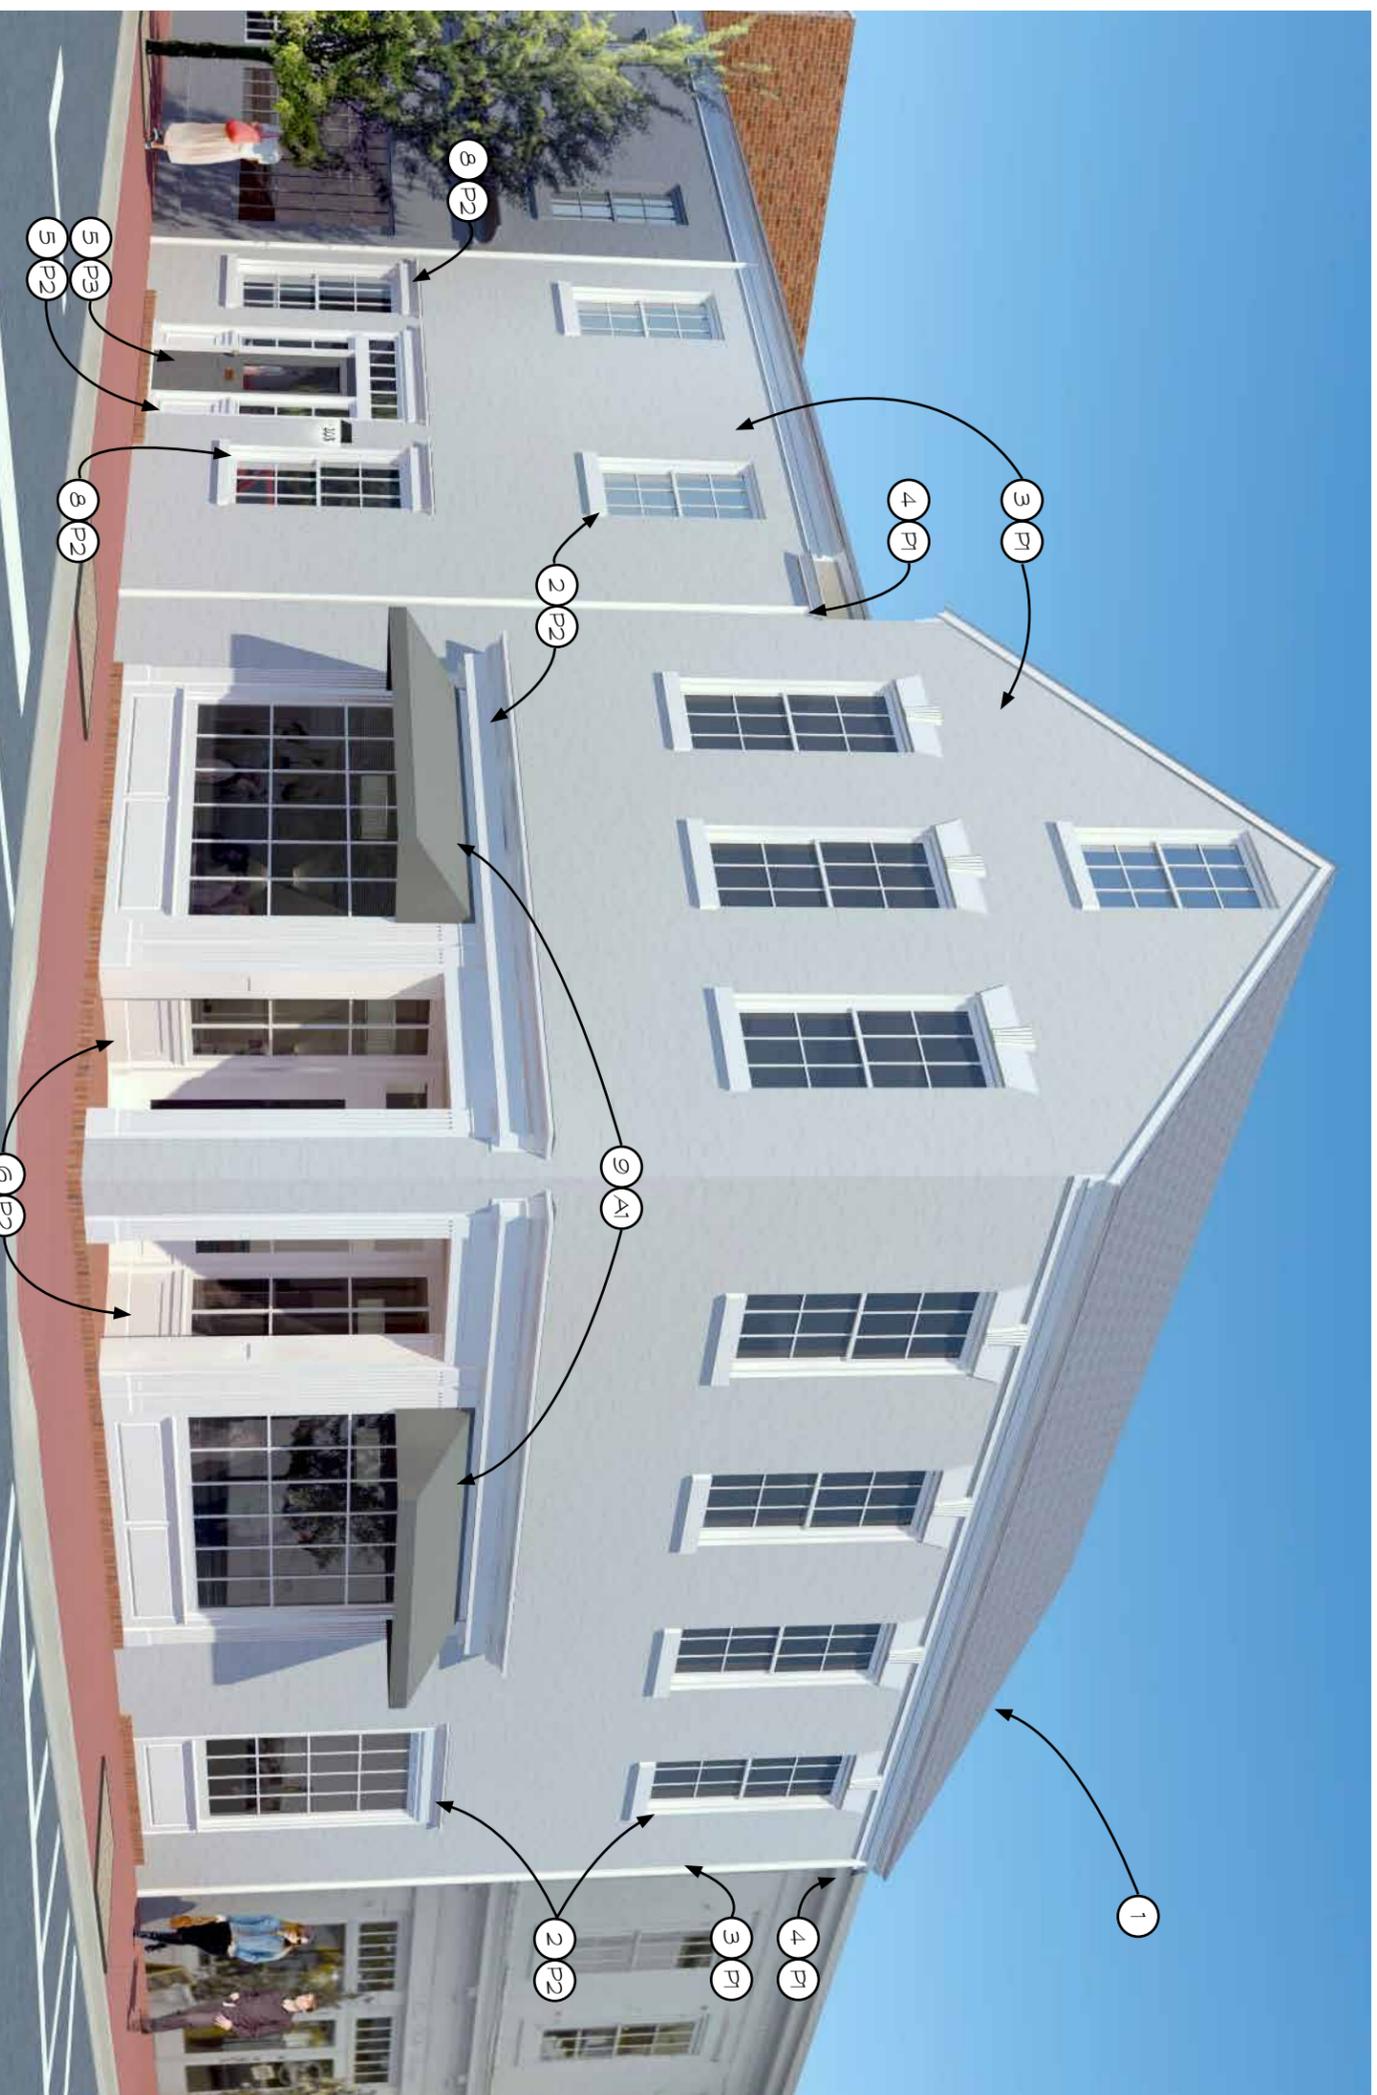
**NEW 1ST FLOOR WINDOWS FOR 203 & AWNINGS - WILLIAM & CAROLINE ST. FACADES**

4. Replace and re-route gutters and downspouts. Paint downspouts to match wall color, and paint gutters to match trim color.
5. Replace wood window with new wood entry door, sidelights and transom to fit opening. Prime and paint. See 203 Williams St. Facade on Sheet A.4.

7. Note not used.
8. Note not used.
9. Install new fabric awnings with loose 6" deep valances and open corners to allow valances to move freely. Tightly fit frame between pilasters and under cornice overhang on 201 Williams St. building.

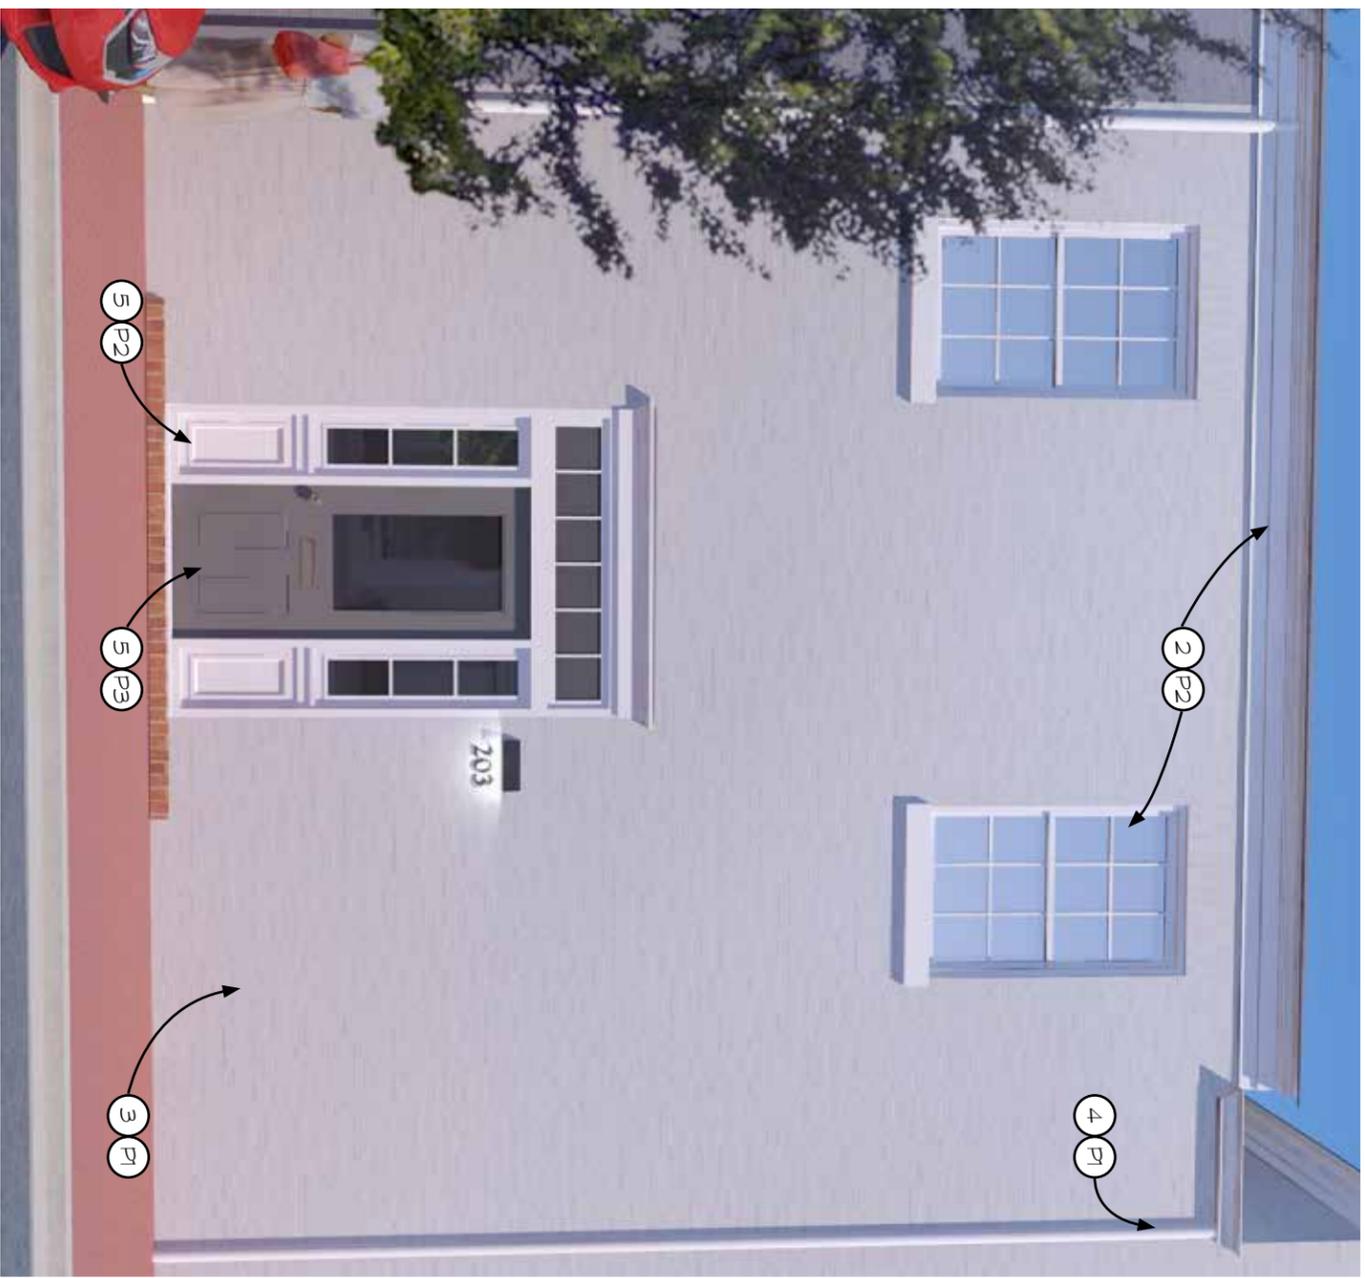
## 203 WILLIAM STREET FACADE

1. Consider repair and patching of slate roof prior to complete replacement with synthetic slate roof shingle. If roof is deemed beyond repair, contact VMS architect for synthetic slate sources that have been accepted in other historic districts in Virginia. Ensure approval of substitute by your municipality prior to purchase of material.
2. \*\*Remove wood shutters. Repair or replace wood trim on first floor storefronts and windows. Prime and paint all trim.

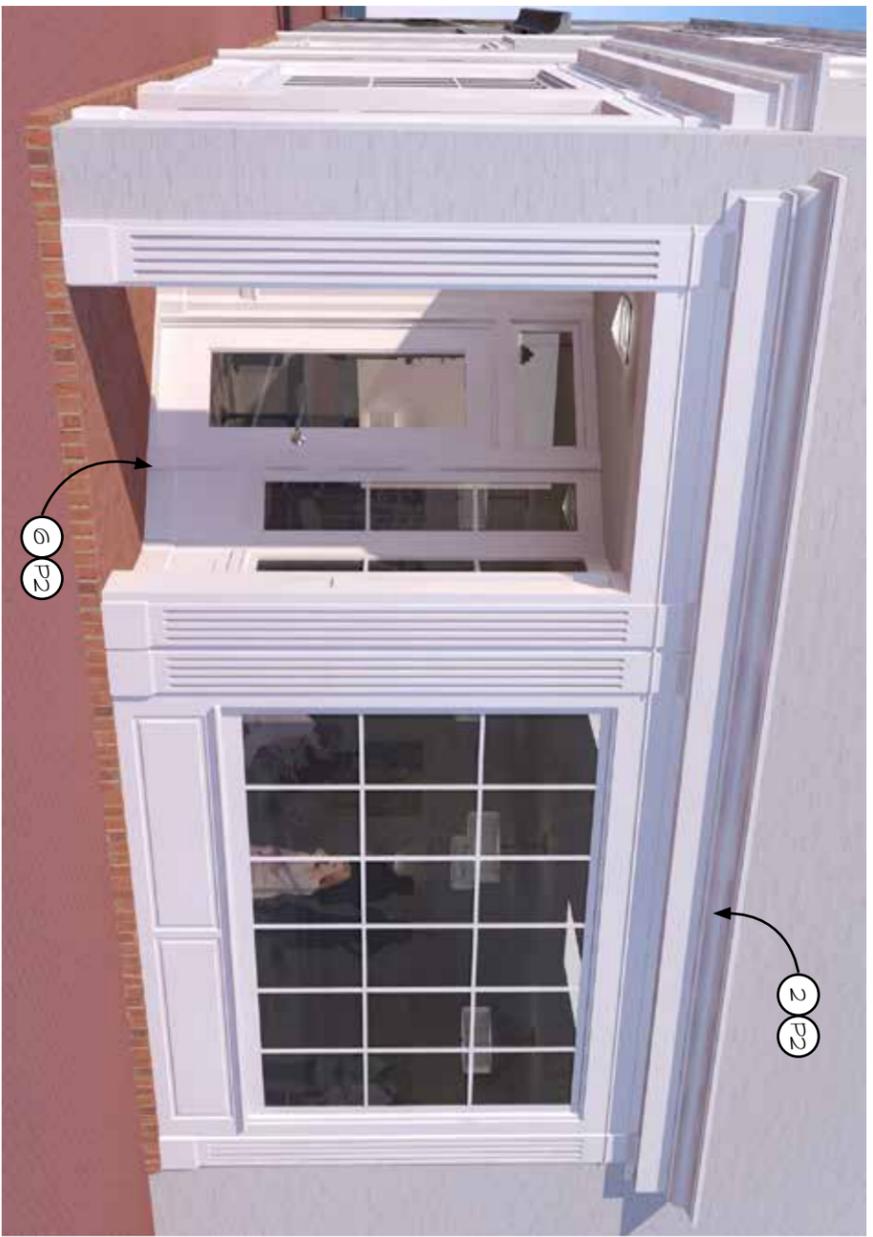
## NEW RECESSED ENTRY DETAIL - FOR 201 WILLIAM STREET BUILDING AS SEEN FROM CAROLINE STREET

3. \*\*Scrape loose paint from existing masonry. Patch and repaint to match existing. Ensure mortar is suitable for early 19th c. brick masonry. Prime and paint.
4. Replace and re-route gutters and downspouts. Paint downspouts to match wall color, and paint gutters to match trim color.
5. Replace wood window with new wood entry door, sidelights and transom to fit opening. Prime and paint. See 203 Williams St. Facade on Sheet A.4.
6. Install new wood recessed entry (3'-0" door) and sidelights using existing entry footprint. Prime and paint. See New Recessed Entry Detail on Sheet A.4.
7. Note not used.
8. Note not used.
9. Install new fabric awnings with loose 6" deep valances and open corners to allow valances to move freely. Tightly fit frame between pilasters and under cornice overhang on 201 Williams St. building.
