## MEMORANDUM

**TO:** ARCHITECTURAL REVIEW BOARD  
**FROM:** Kate Schwartz, Historic Resources Planner  
**DATE:** May 9, 2016  
**SUBJECT:** Certificate of Appropriateness for exterior alterations at 209 Prince Edward Street

Jay Lewis requests a Certificate of Appropriateness for exterior alterations including:

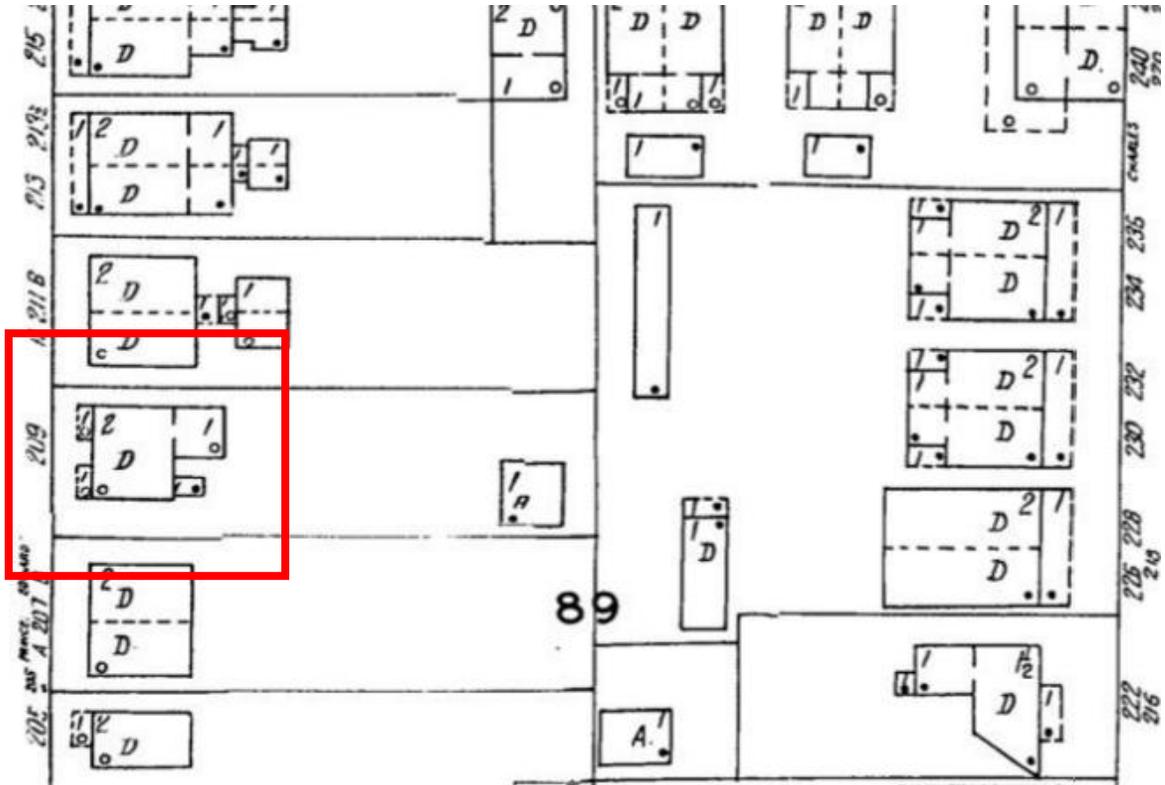
**1927 Sanborn Fire Insurance Map**  
Note two entry porches at 209 Prince Edward Street.

- The existing entry portico and posts will be removed and replaced with a full-width, six-foot deep, shed-roofed porch supported by eight-inch wood posts. The portico appears to be a non-original feature. The 1947 Sanborn Fire Insurance Map shows two one-story entry porches projecting off the front façade. Neither of these matches the existing entry. The proposed porch design aligns with many examples in the surrounding neighborhood and is an appropriate style for the residence and the district.

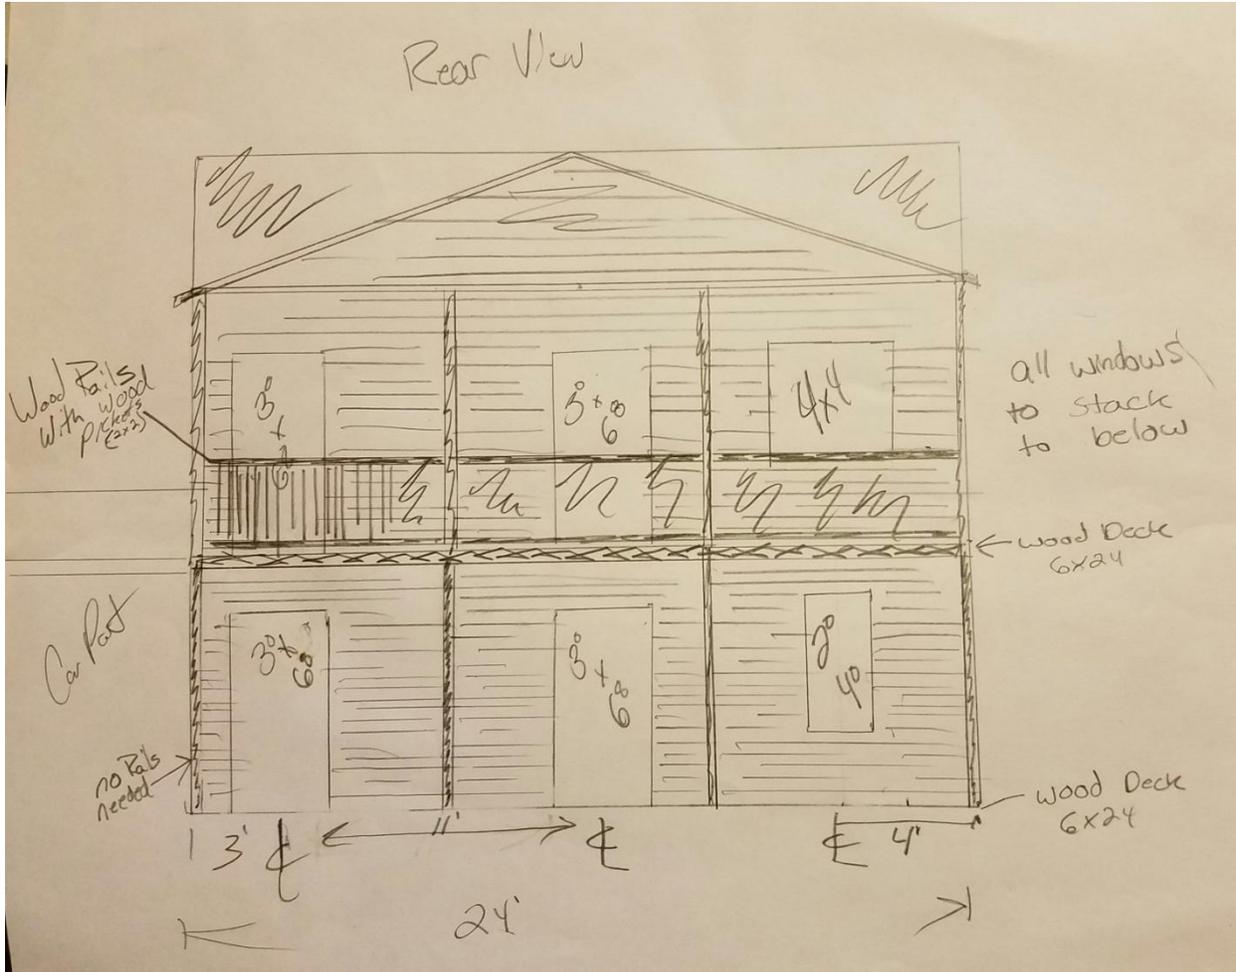
**Rear Elevation**

Provided for reference; not visible from public right-of-way

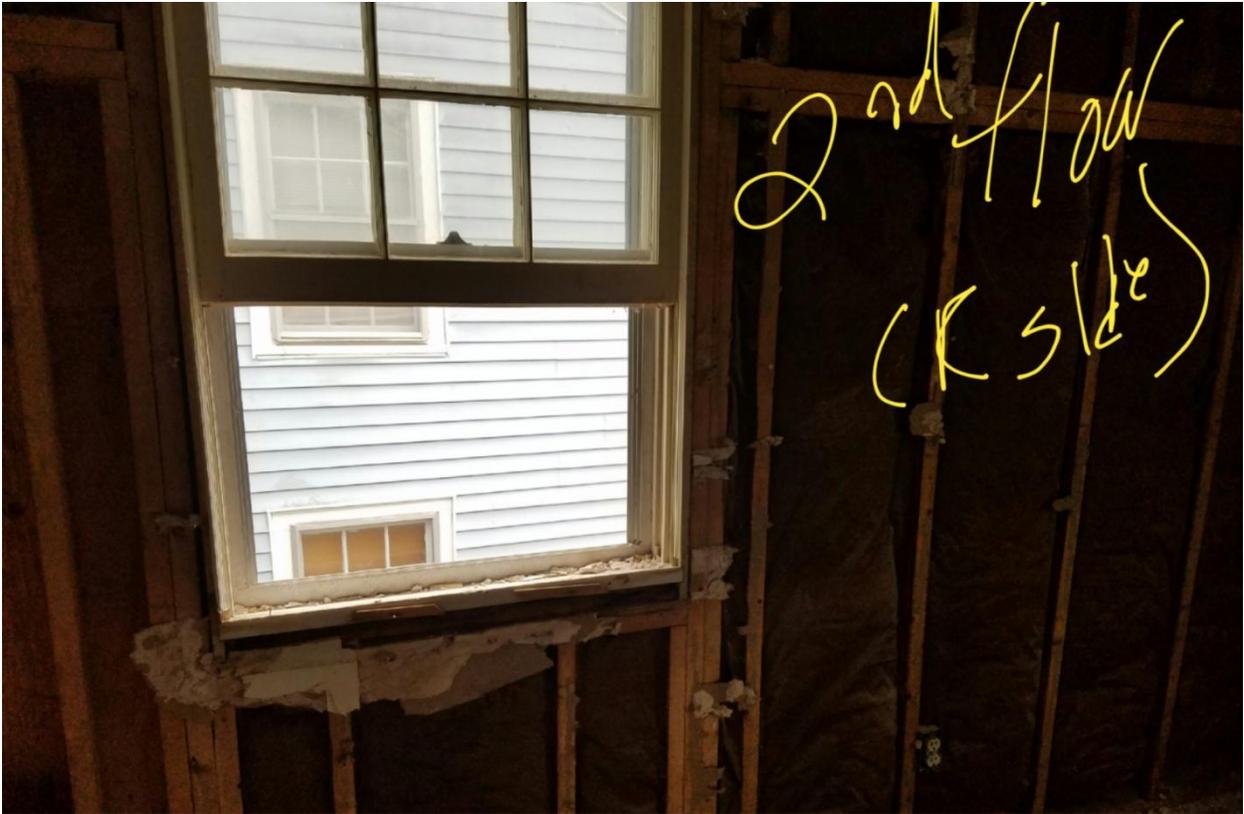
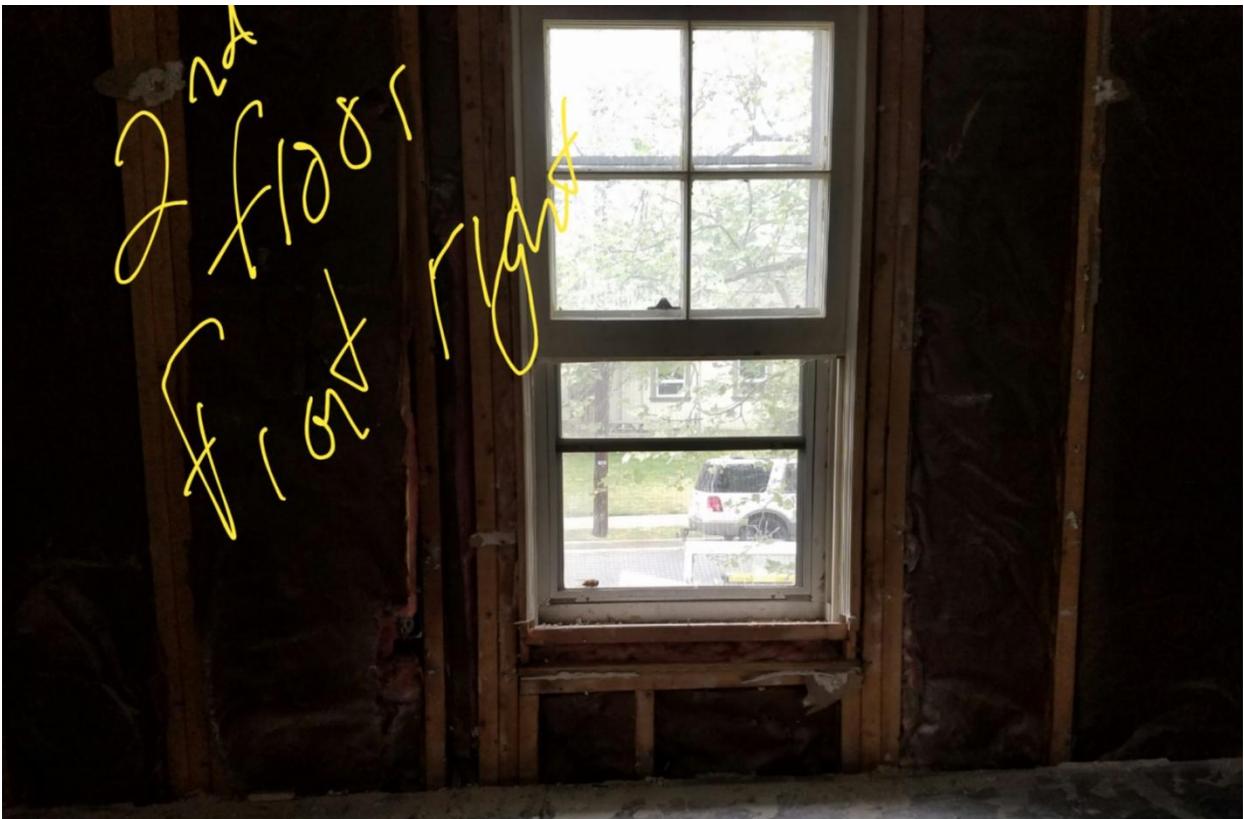
Existing Windows, images provided by applicant

Removal of the existing wood windows is not recommended. Though the upper-story windows on the front elevation are not centered over the door and paired window below, they are evenly spaced across the upper story. Relocating these windows may accentuate the asymmetry rather than improving the configuration. Rearranging the windows on the side elevation is also not recommended.

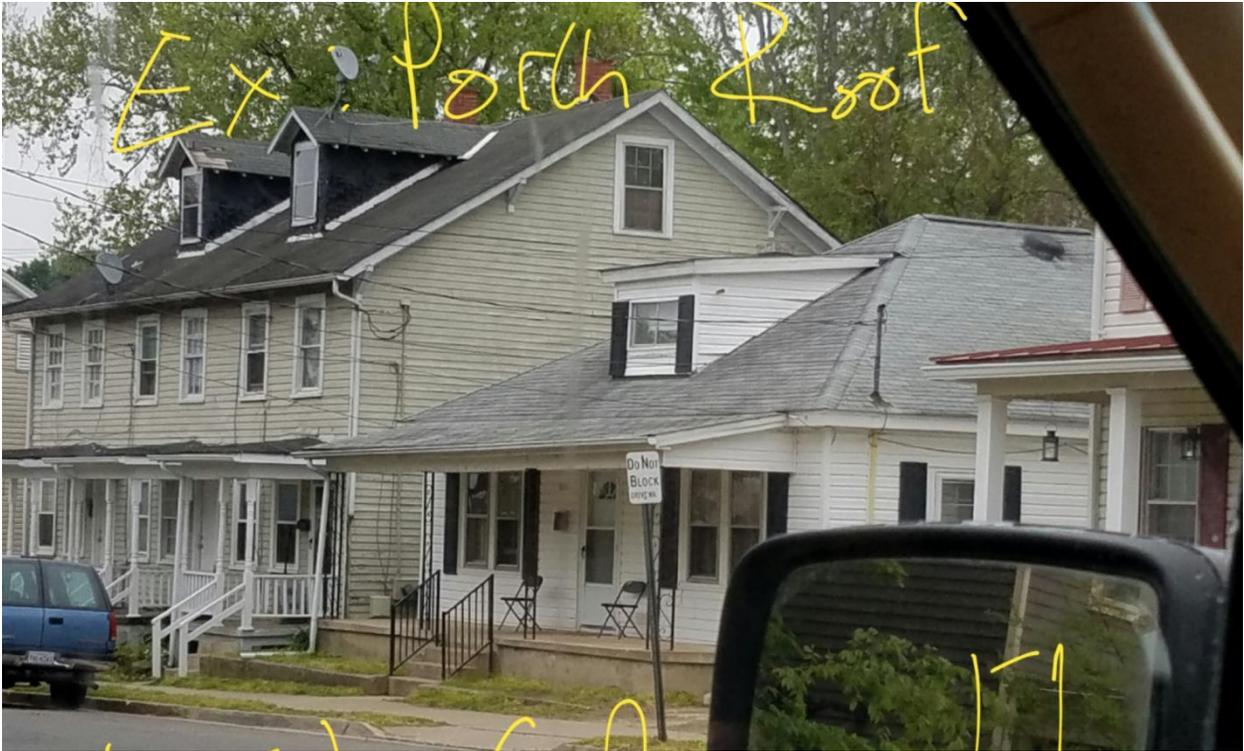
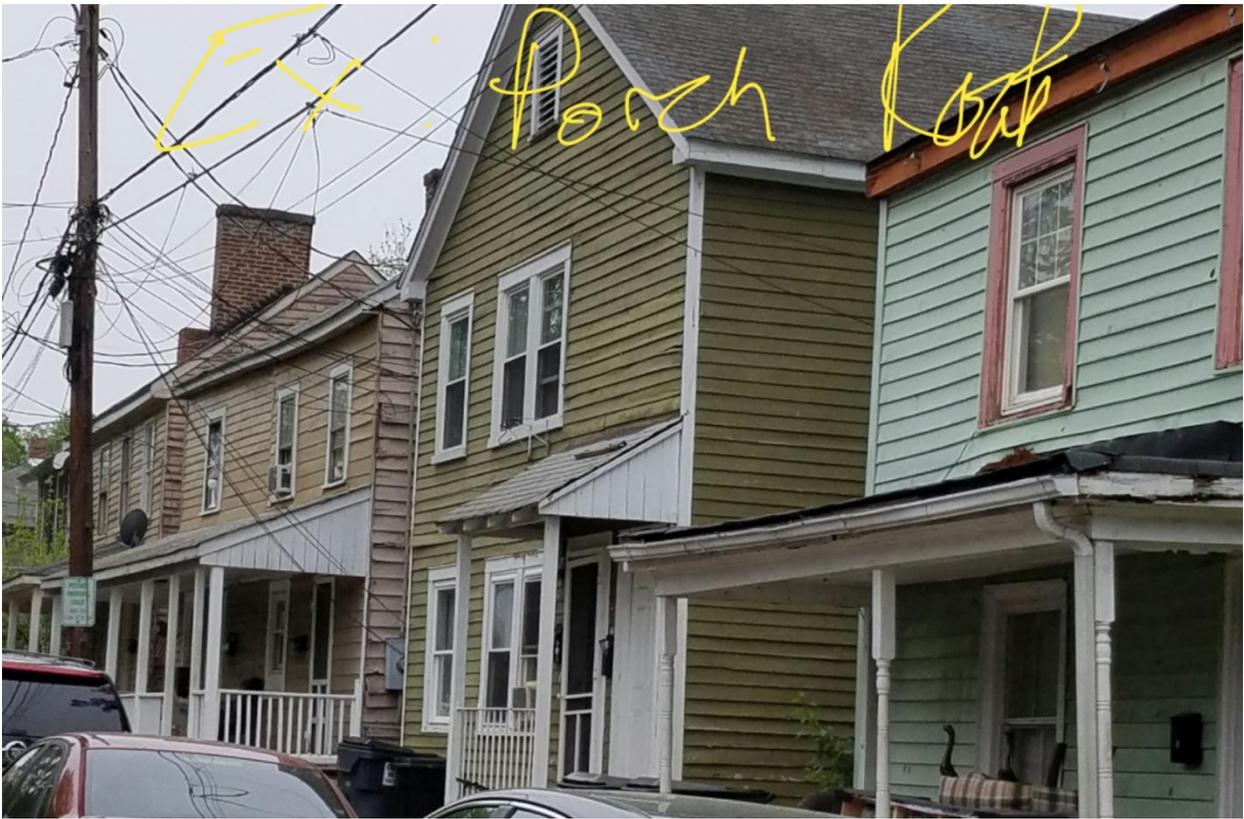
Context images for porch design provided by applicant

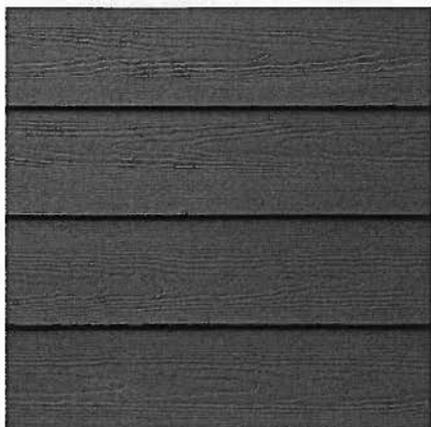
**James Hardie HardiePlank Primed Iron Gray Cedarmill Lap Fiber Cement Siding Panel (Actual: 0.312-in x 6.25-in x 144-in)**

Series Name	HardiePlank	Painted	Yes
Actual Thickness (Inches)	0.312	Finish Warranty	15-year limited
Actual Length (Inches)	144	Texture	Cedarmill
Actual Width (Inches)	6.25	Color/Finish Family	Gray
Manufacturer Color/Finish	Iron Gray	Type	Lap
Warranty	30-year limited	Primed	Yes

- The aluminum trim and vinyl shutters will be removed and all openings will be framed with simple painted wood trim.
- As part of the scope of work, the asphalt shingle roof will be replaced in-kind, which does not require ARB approval. All eaves will be boxed with painted wood. Dentil trim will be added under the eave on the front elevation. Staff finds the proposed design compatible with the Colonial Revival character of the structure.
